## NON-COMPLIANCE ADVISORY LETTER

## Rockford Region Agricultural Field Investigation Report

Hunter Haven Farm – 17990A IL Rt 73, Pearl City, IL – 4/19/12 Inspection

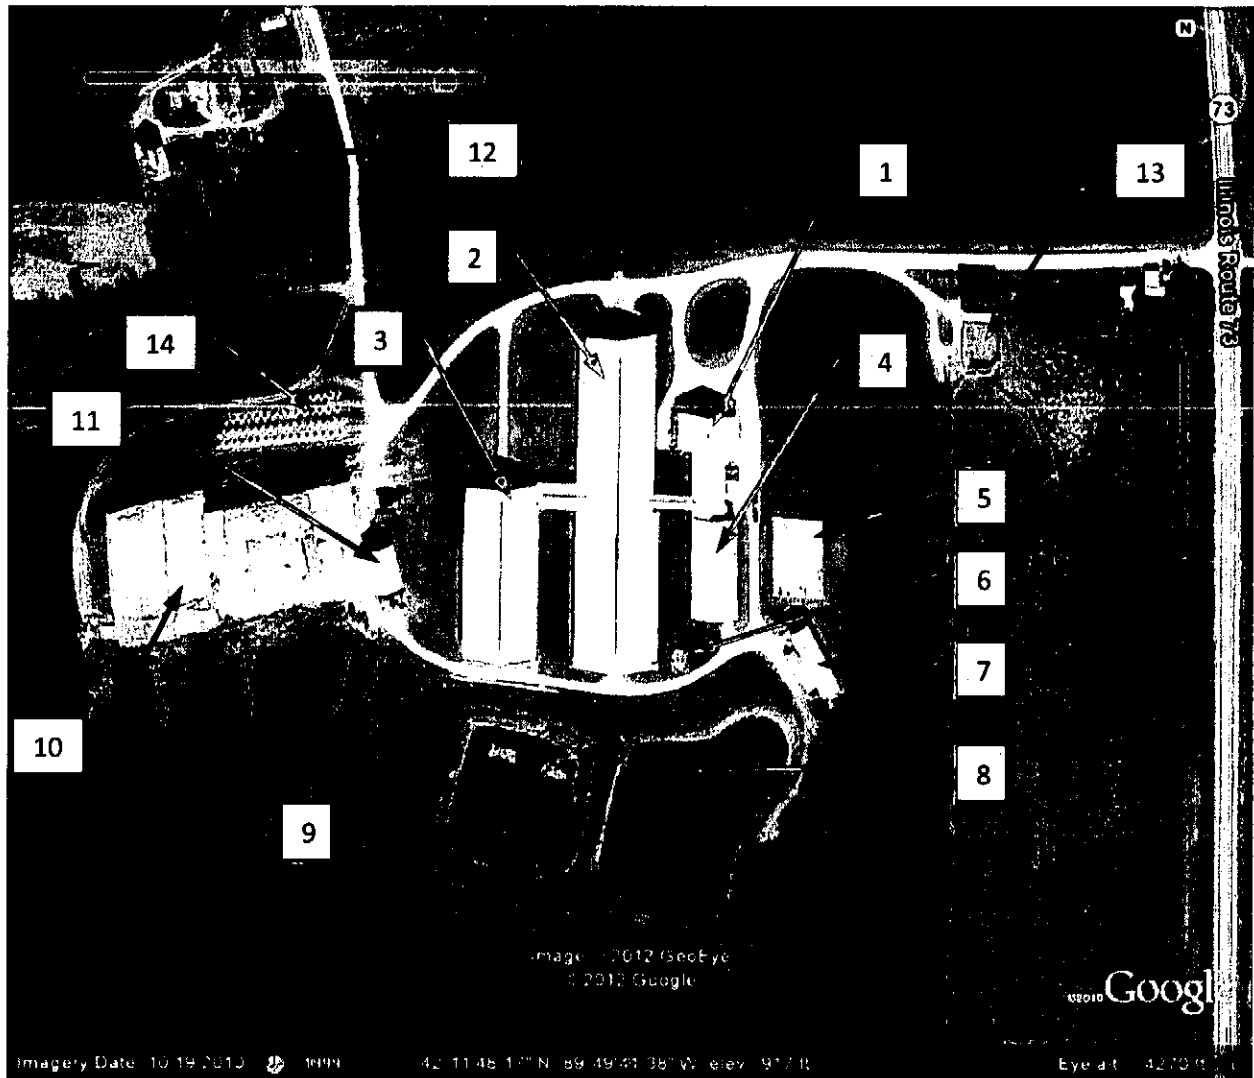
Map Point	Description
1	Office and Milking Parlor
2	Freestall barn with 560 stalls – waste is scraped to south end and flushed to reception pit via a flume
3	Freestall barn with 180 stalls – waste is scraped to south end and flushed to reception pit via a flume
4	Pre-fresh barn with 67 stalls – waste trough is flushed to reception pit with milking parlor wastewater
5	Digester
6	Reception pit
7	Solids separator building with manure solids production for use as compost and recycled bedding. The south part of building houses generators that produce electricity from methane produced by digester
8	Primary lagoon – 1.57 MG working volume (2.58 MG total volume)
9	Secondary lagoon – 1.57 MG working volume (2.58 MG total volume)
10	Silage bunkers. Runoff enters vegetated area that drains to cropfield. East Fork Creek is 2000 ft to south
11	Commodity shed, bulk bins, and condensate of whey tanks
12	Feedlot for summer pasture. Runoff flows through vegetated area toward unnamed tributary

13	Barn and feedlot for excess pre-fresh cows. A manure storage bunker is south of the feedlot.
14	Calf hutches – no longer in use
